METALS HANDBOOK

VOL. 9
FRACTOGRAPHY AND ATLAS OF FRACTOGRAPHY

8th EDITION

Fractography and Atlas of Fractographs

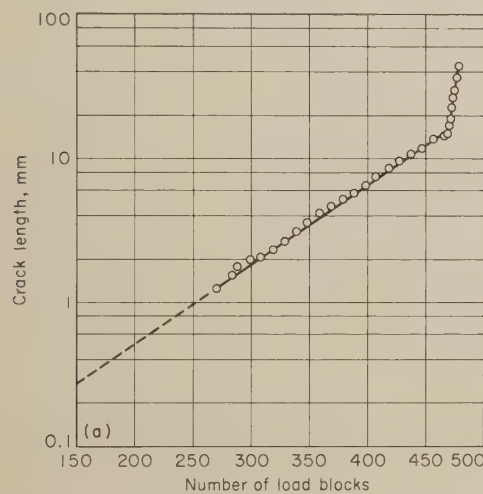
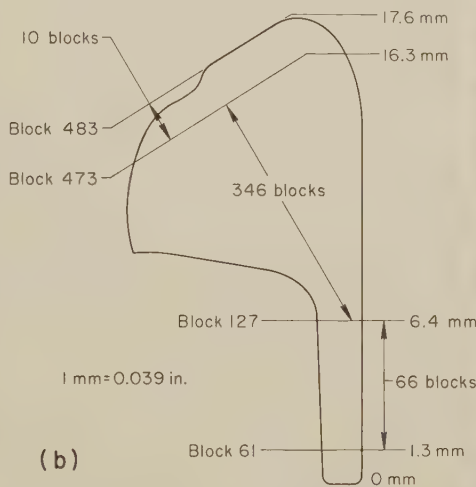
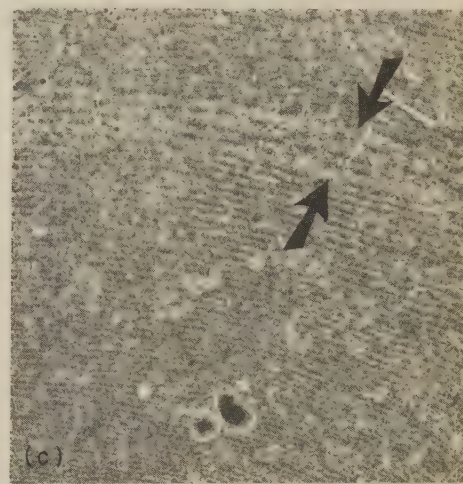
Fig. 38. Analysis of fatigue-crack-growth rate for the 4340 steel finger in Fig. 37 (Example 14)

(a) Crack length versus the number of applied load blocks for the major critical fatigue crack in the finger (the surface of this crack is shown in Fig. 37b).

(b) Sketch that relates fatigue-crack growth to the number of applied load blocks on the surface of a less-critical crack in the vertical member (surface

at upper right in Fig. 37c). The outline shows the shape of the fracture surface.

(c) Transmitted-light fractograph, at 14 \times , through a plastic replica of the fracture surface, showing four extra-wide bands (between arrows) corresponding to load blocks 440 to 443 on the fracture surface.

- 3 Final, fast fracture of the sections remaining at the ends of all four cracks occurred simultaneously. This was demonstrated by the presence of four extra-wide block bands on all four fracture surfaces, corresponding to blocks 440 to 443. (The four bands of the fracture shown in Fig. 38c were formed by loading-system perturbations during the course of these four load blocks.) In all four cracks, fast fracture occurred at a count of 40 bands after the fourth extra-wide band previously identified as band 443.

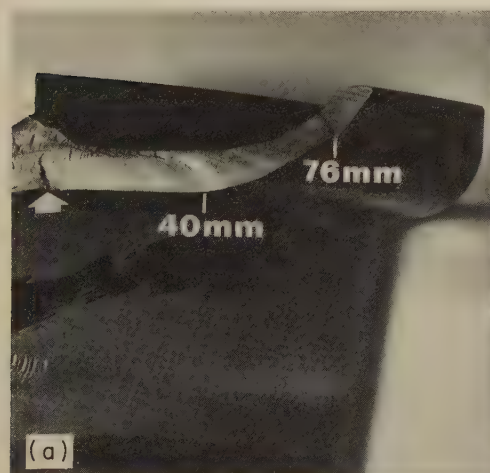
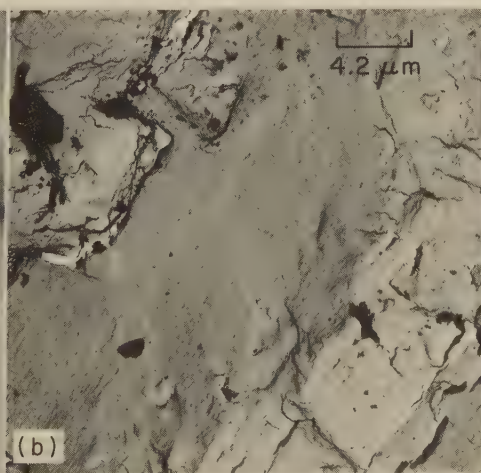
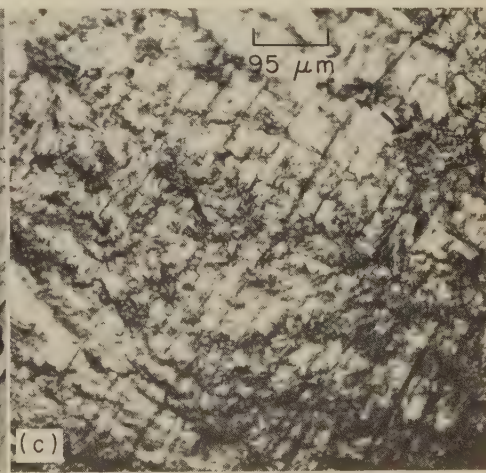
Fig. 39. Fatigue crack that formed in service in a forged aluminum alloy 2014-T6 aircraft wheel. See also Fig. 40. (Example 15)

Light fractograph

(a) Fracture surface showing macroscopic bands of fatigue-crack growth. The location of the crack origin is indicated by the arrow. The growth of the fatigue crack was symmetrical in both directions from the origin; 76 mm therefore equals the half-crack length.

(b) A TEM fractograph of fine fatigue striations in crack-growth bands.
(c) Microscopic fatigue-crack-growth bands corresponding to the bands shown in fractograph (a). This transmitted-light fractograph was made through a plastic replica of the fracture surface.

Information on rate of fatigue-crack growth was gathered from the fracture surface of a wheel over a distance of 76 mm from the crack origin (Fig. 39a). The fracture-surface topography, illustrated in Fig. 39(b) (a TEM fractograph), shows bands containing areas of fine striations that, on the basis of a sampling of macroscopic band-spacing measurements, are believed to correspond to the macroscopic crack-growth lines shown in Fig. 39(c), a transmitted-light fractograph.

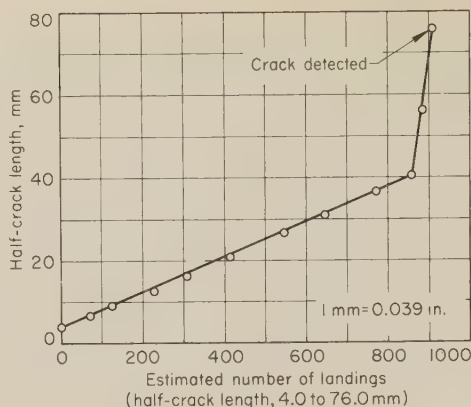
Fig. 40. Fatigue-crack length vs estimated number of landings (after crack initiation) for the fractured alloy 2014-T6 aircraft wheel in Fig. 39 (Example 15)

The graph in Fig. 40 accounts for 903 bands over the half-crack length from 4 to 76 mm. (The total number of landings, including those prior to crack initiation, was far greater than 903.) The crack exhibited an approximately constant growth rate of some 47 microns per band over the interval from 4 to 40 mm of crack length. Over the interval from 40 to 76 mm, the crack-growth rate exhibited an abrupt increase to about 650 microns per band. This latter interval corresponded to a clearly defined change in fracture-surface topography (Fig. 39a) with a definitely coarser texture than the initial 40 mm of crack growth.

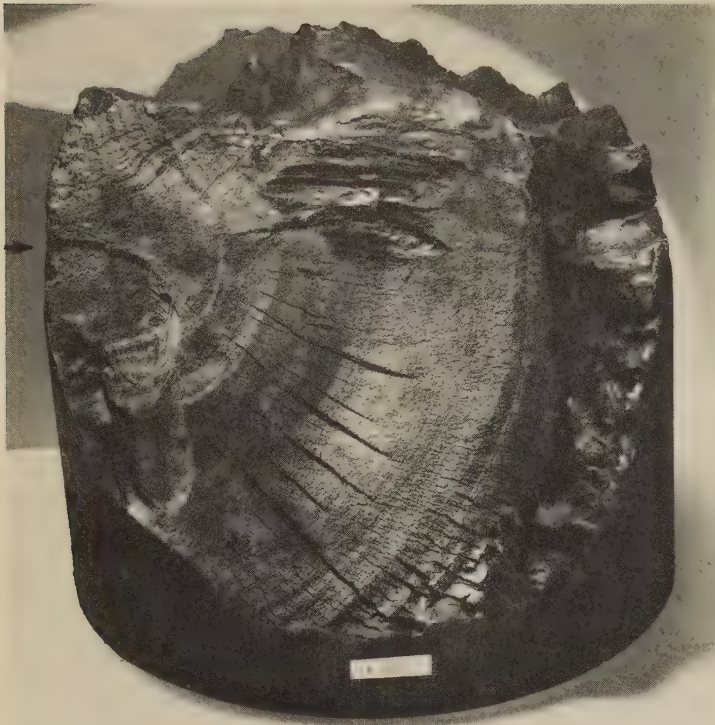
3418 Fracture surface of a carbon steel drive shaft of a 200-gross-ton marine tug. The shaft failed by corrosion fatigue after seawater displaced the lubricant between the shaft and the stern tube. Beach marks indicate that the fracture origin was at left (arrow). See also 3419 to 3422.

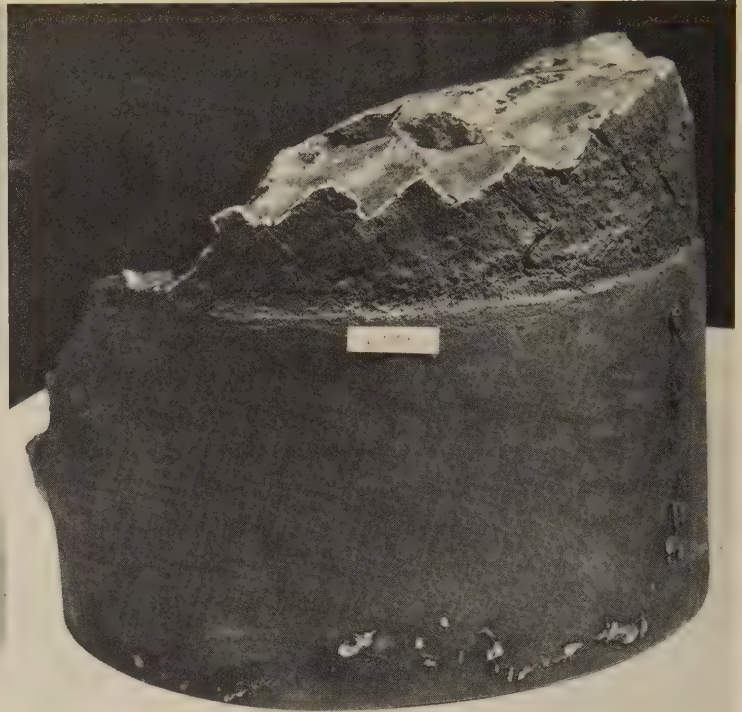
3419 Side view of the fractured drive shaft in 3418. Note the serrated profile (retouched for clarity) of this edge of the fracture surface and the diagonal cracks on the shaft surface. The cracks were caused by corrosion fatigue from the combination of reversed shaft torsion, perhaps some bending, and seawater attack.

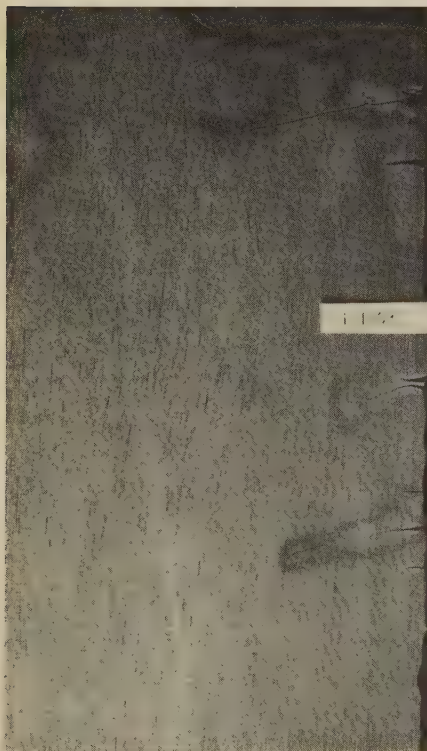
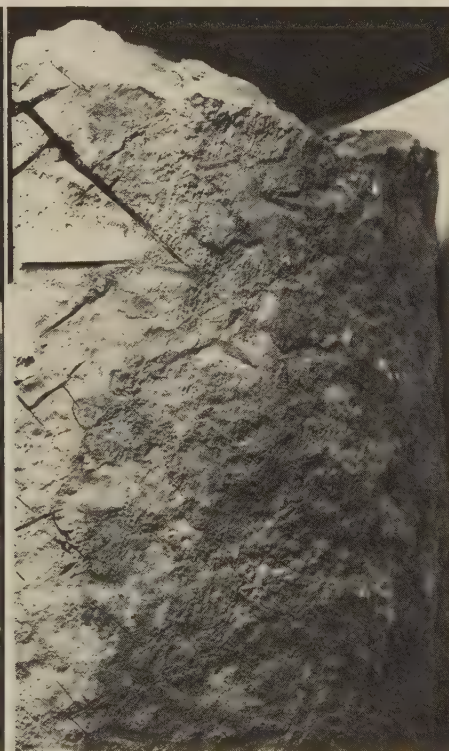
3420, 3421 Macrograph 3420 (at left) shows a macroetched section of the fractured shaft in 3418. Fractograph 3421 (at right) is a view at 90° to that in 3420 and shows the shaft surface, containing diagonal cracks (3420 shows depths of these cracks). Note in 3421 that the seawater produced not only corrosion-fatigue cracking but general surface corrosion as well.

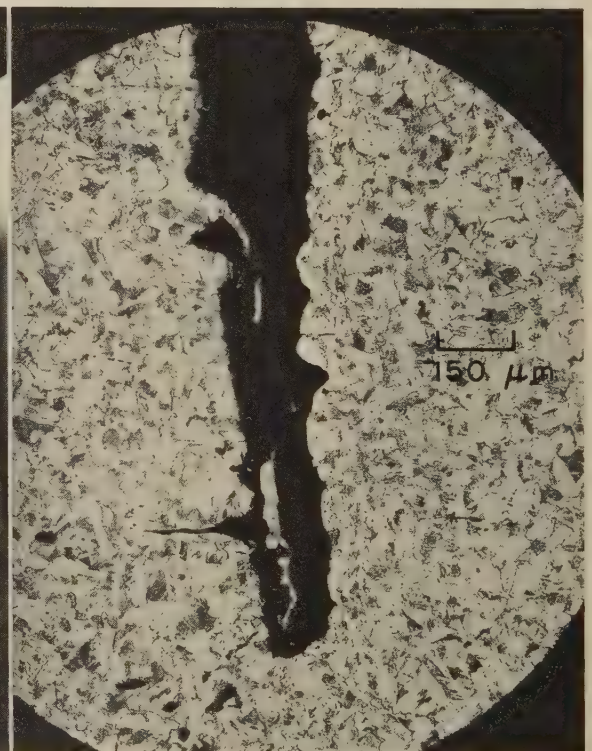
3422 A section of the fractured shaft shown in 3418, revealing the bottom of one of the corrosion-fatigue cracks. Note that corrosion blunted the tip of the main crack but not the tip of the sharp secondary crack at left, which formed later.

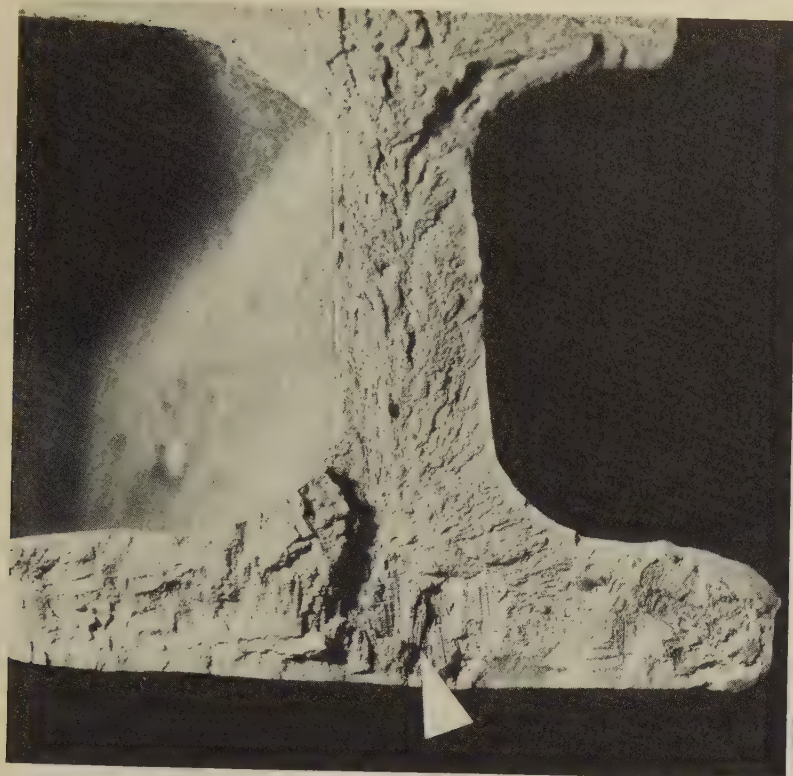
3423 Surface of a transverse fracture produced by impact in a cast carbon steel frame bar of a tractor chassis. A region of weakness is evident in the area of internal shrinkage porosity marked by the arrowhead at bottom. This area of porosity can be identified by the fine-scale dendrites above the arrowhead to left and right.

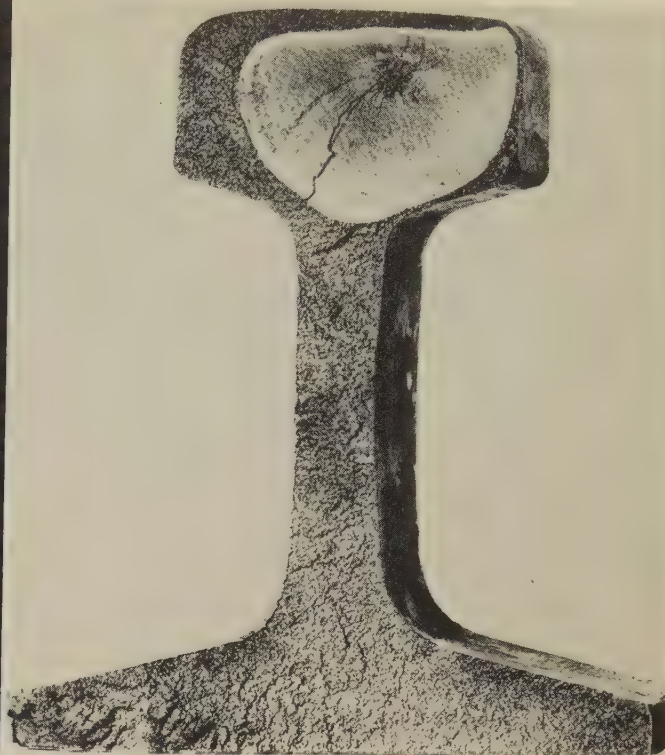
3424 Surface of a transverse fracture in an AREA 110-lb railroad rail made of 1075 steel. The fracture nucleus (small dark area near the top of the railhead) is a hydrogen-induced flake (or "fisheye"), which initiated a fatigue crack (large light zone surrounding the nucleus).

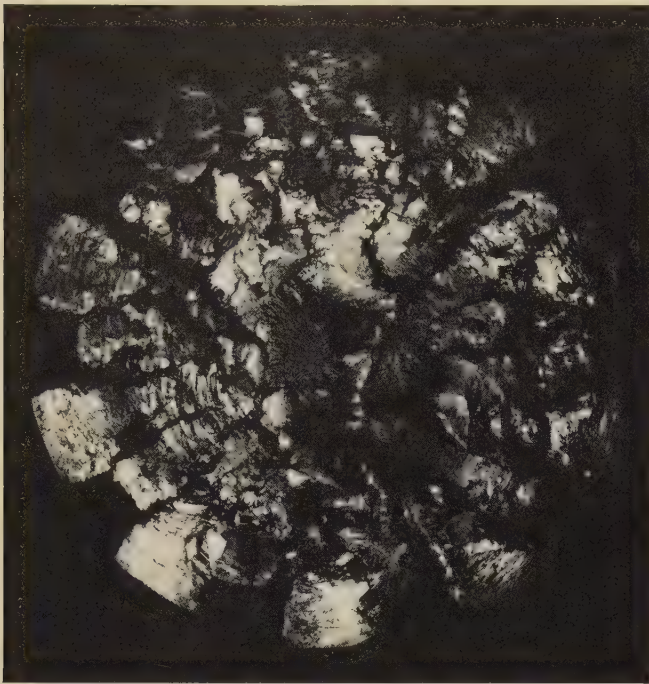
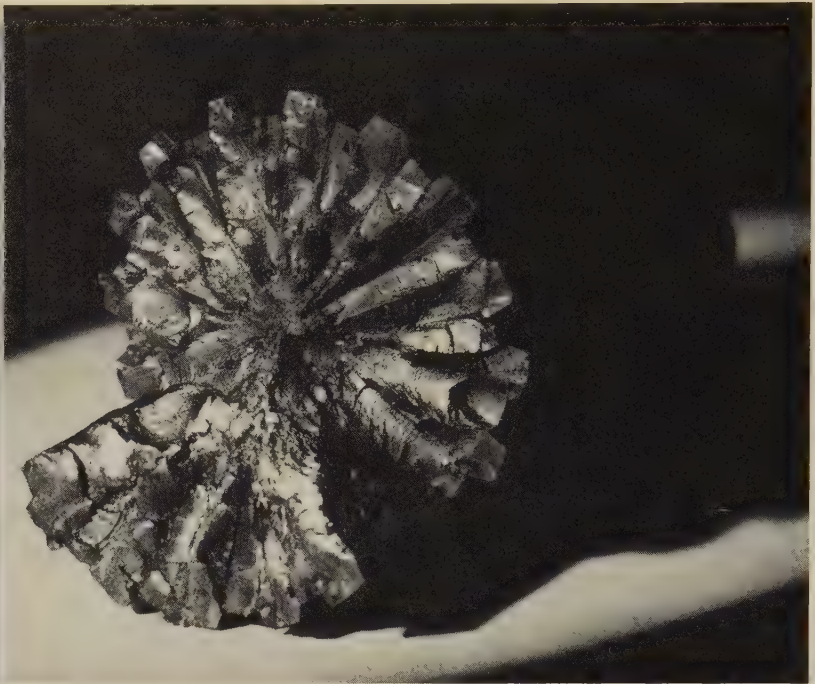
3429, 3430

Multiple-origin fracture surfaces in two splined steel shafts. The fracture in 3429 (at left) is in a 2½-in.-diam shaft of low-carbon steel in the as-hot-worked condition that was tested in torsional fatigue. The fracture in 3430 (at right) is in a 1¼-in.-diam automotive shaft of low-alloy steel that failed by torsional fatigue in service. In both fractures, fatigue cracks originated at the sharp notches in the groove fillets at the base of the splines and propagated both circumferentially (connecting with one another in the process) and radially toward the center. Also in both fractures, the fractured parts were sufficiently locked together by the complex fracture path that rubbing obliterated nearly all details of the fatigue cracks.

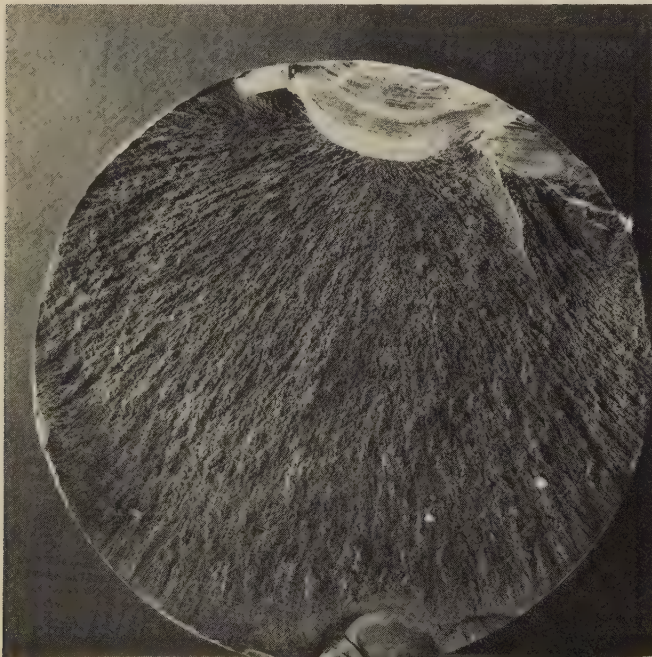
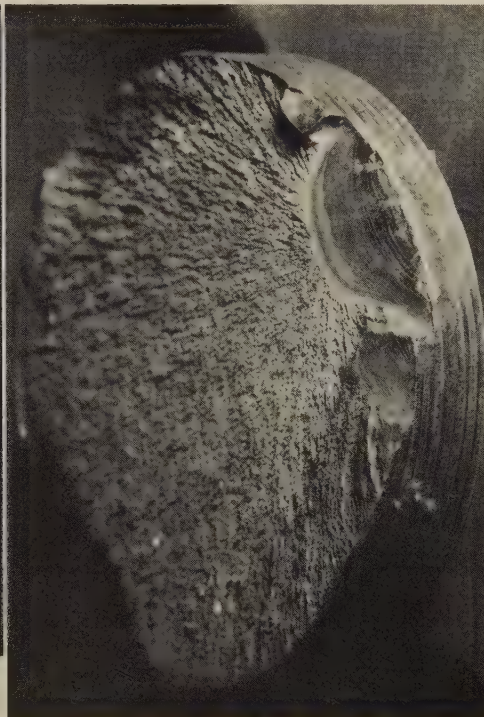
3431, 3432

Two views of the surface of a fatigue fracture in a 5/8-in.-diam threaded piston rod of 4340 steel heat treated to 341 Bhn. The full-face view in 3431 (at left) shows plainly the beach marks in the region of the primary fatigue crack, at top. Secondary fatigue cracks are visible on either side of it as well as at the bottom. The oblique view in 3432 (at right) reveals that the fatigue cracks began at the roots of the threads, the origin of the primary crack being two threads to the right of the abutting secondary cracks. Although these reduced-size views do not permit detailed scrutiny, it seems evident that the thread roots were too sharp, causing stress concentrations locally. Beyond the fatigue-zone limits, failure was by radial fibrous fast fracture.

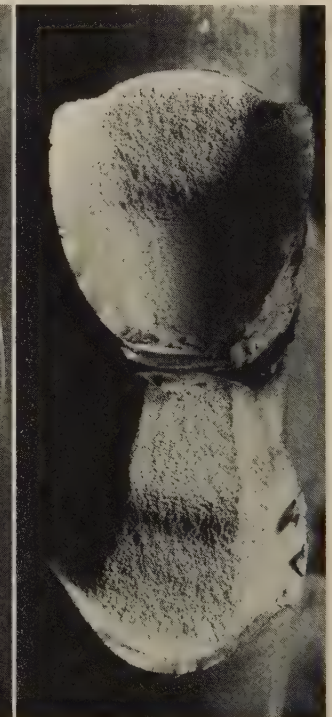
3433 Matching fracture surfaces of a 4340 steel helicopter bolt that was broken by notch bending. Observe the fine markings, which are fibrous tear ridges. Note the very large shear lips.

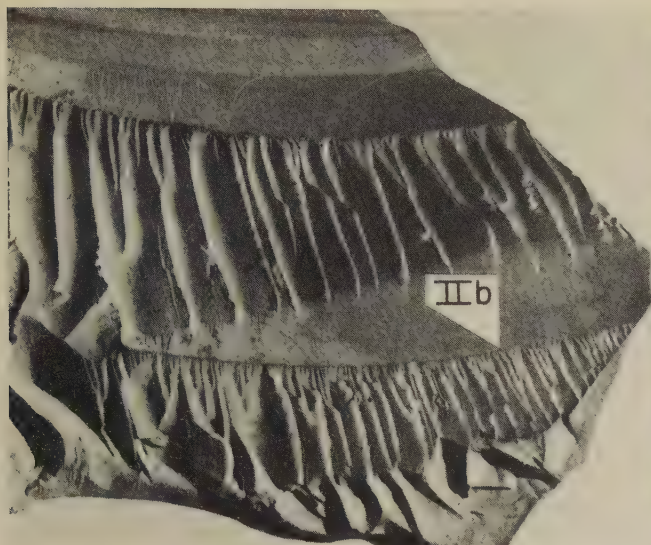
3434 Surface of an impact fracture in a 4-in.-thick section of class A steel armor plate (0.30% C, 3.65% Ni, 1.45% Cr). The fracture temporarily halted (at arrow-head marked "IIb") before completing the penetration; this interruption was probably due to a pulsation in stress.

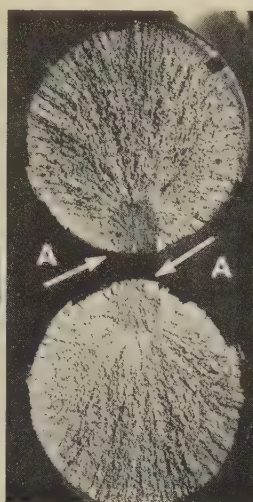
3435 Mating fracture surfaces of eccentrically loaded tensile specimen of A4N tool steel. Note fibrous zones of initial fracture (A).

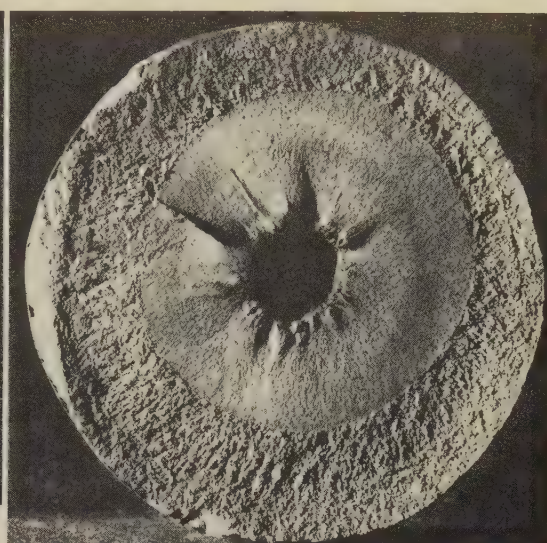
3436 A surface of a fatigue fracture that originated at the inside of a hollow drill of class 110 (W1) tool steel. Fracture initiation was attributed to distortion of the bore of the drill during the production of a hot upset joint.

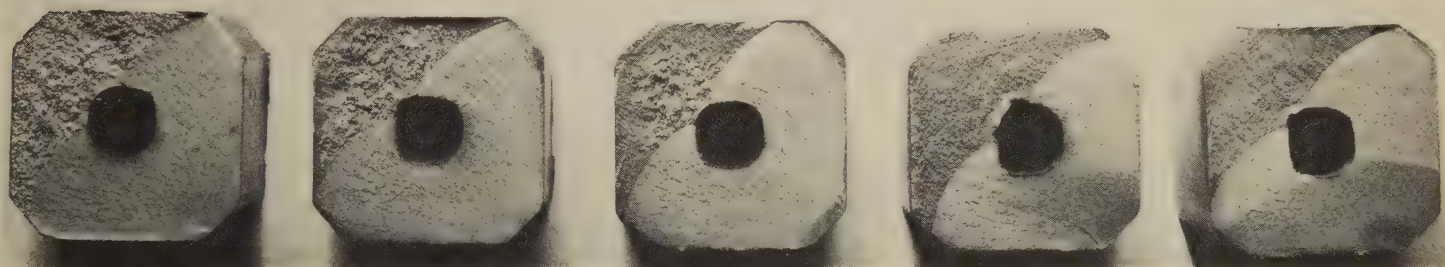
3437 Five fatigue-fracture surfaces that were produced in reversed bending in a pneumatic testing machine. The material is class 110 (W1) tool steel. The lighter areas of the fracture surfaces are the fatigue zones — all of which were initiated at the lower right corners. Note the lack of beach marks, which indicates that during each test the load amplitude and environment were uniform. The dark regions at the upper left corners are the regions of final, fast fracture.

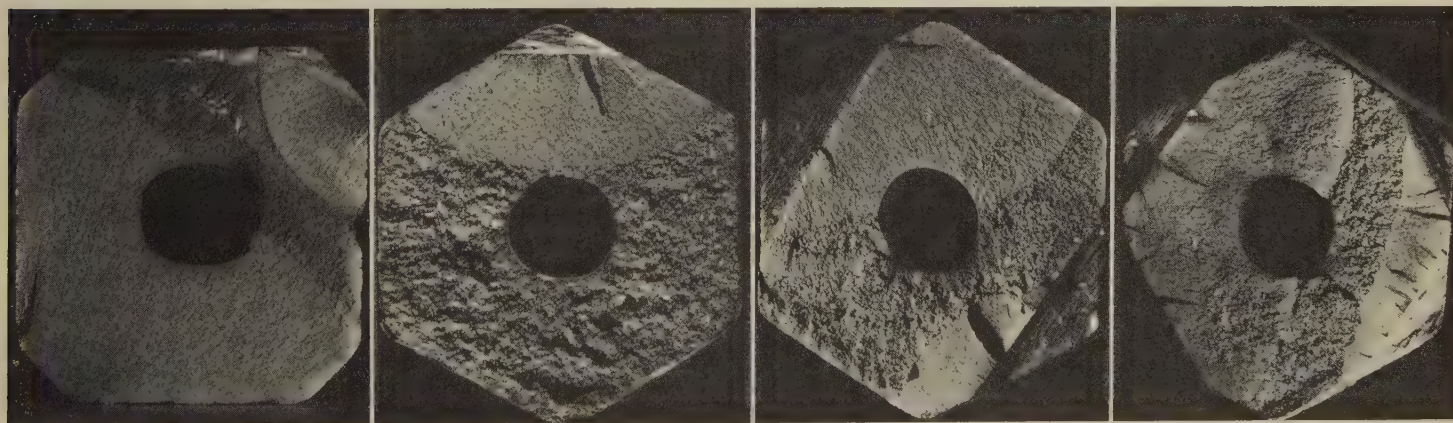
3438, 3439, 3440, 3441 Four fatigue-fracture surfaces that were produced in bending in the laboratory with the use of assorted notches to simulate service conditions; the material is class 110 (W1) tool steel. The specimen in 3438 (far left), which was tested without a notch and fractured after 432,000 cycles at 365 MPa (53 ksi), shows two crack origins at opposite corners where bending was maximum. The specimen in 3439 (second from left) had a single notch at top and broke after 20,500 cycles at 434 MPa (63 ksi); note the small shear lip around the region of fast fracture at bottom. The specimen in 3440 (third from left) was notched at two corners that were along an axis not in the plane of bending and broke after 50,000 cycles at 338 MPa (49 ksi); the two resulting fatigue cracks therefore had somewhat distorted shapes. The specimen in 3441 (far right) was notched at four sites — two in the bending plane and two in a plane at 60° from it — and broke after 10,260 cycles at 434 MPa (63 ksi). The four notches produced fatigue zones, which formed two major crack fronts that nearly penetrated the section.

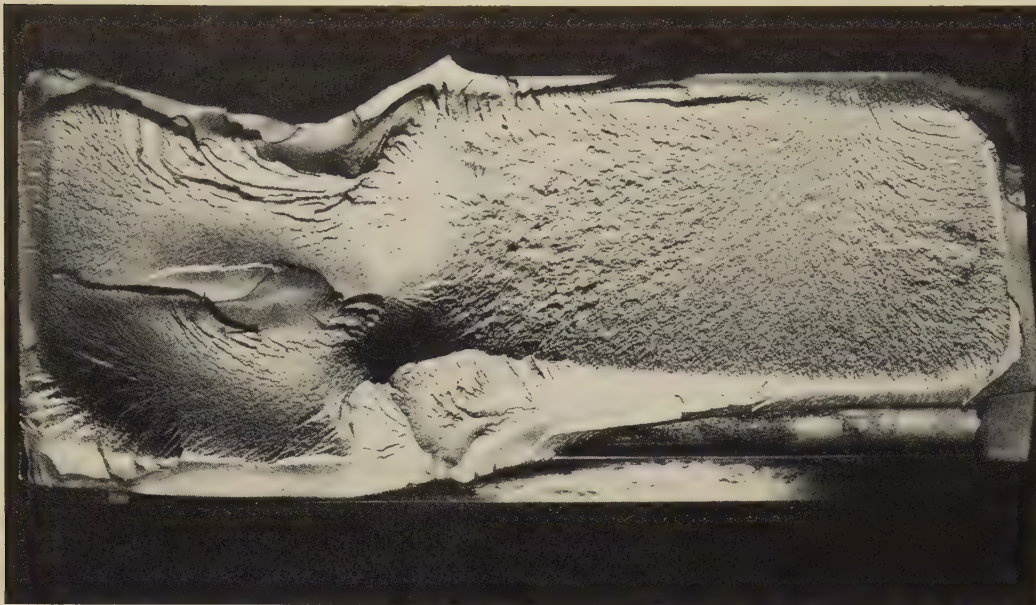
3442 Surface of a catastrophic fracture in an open-header die of class 120 (W2) tool steel that was case carburized to 0.95% C at the surface, heat treated in the range of 815 to 845 C (1500 to 1553 F), and water quenched. This die was used for cold forming and upsetting square heads. Upsetting stresses opened a small fatigue crack in the hardened case in the top edge near the upper right corner; it is to this area that the markings of radial fibrous fracture in the core of the die may be traced. The region of fast fracture encompasses nearly the entire fracture surface. Note the fine-grained, sharply defined case that frames the fibrous core.

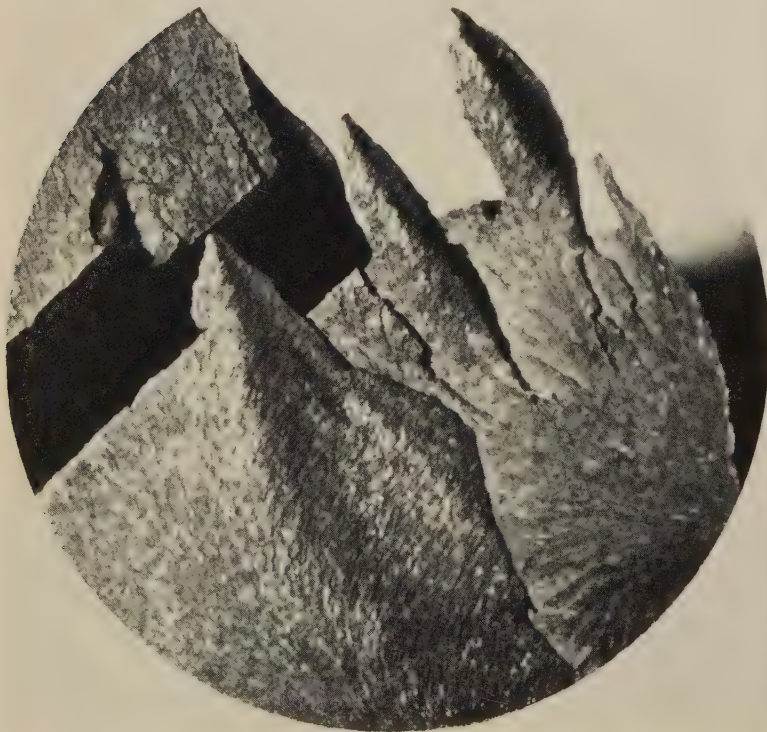
3446 Surface of an impact fracture in a shear blade of class 234 (L6) tool steel heat treated to a hardness of Rockwell C 55. The impact generated the two crack fronts whose junction may be seen at the secondary fissure that enters the field of view at lower right; the radial markings on either side clearly meet this fissure at divergent angles. A third and separate crack front (at top left) met these two crack fronts at the wide secondary crack beneath the projecting shards.

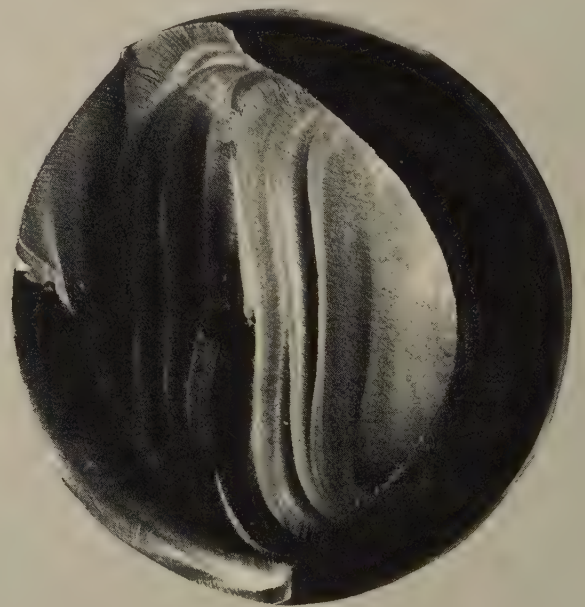
3447 Surface of a low-cycle fatigue fracture in the collar of a rivet-heading tool of class 320 (S1) tool steel heat treated to a hardness of Rockwell C 56 to 58. Following the development of the smooth fatigue zone at right, fracture occurred in a few hours of service, generating the unusual beach marks at center and left.

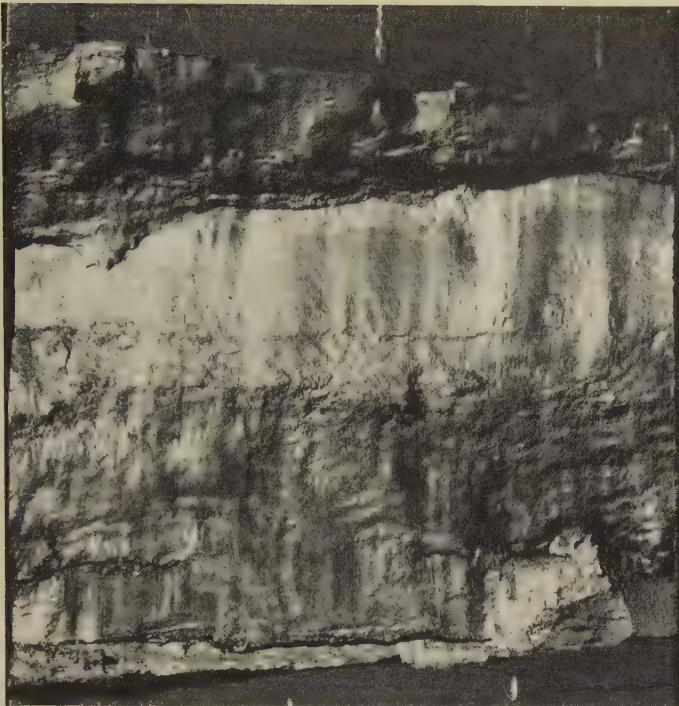
3448 A "hammer-burst" fracture at the center of a 5 1/4-in.-diam, 1 1/2-in.-thick forged disk of class 610 (T1) tool steel. This longitudinal fracture shows a surface of either a lap or a cold shut; the appearance of such a fracture is often called "platy" or "laminated".

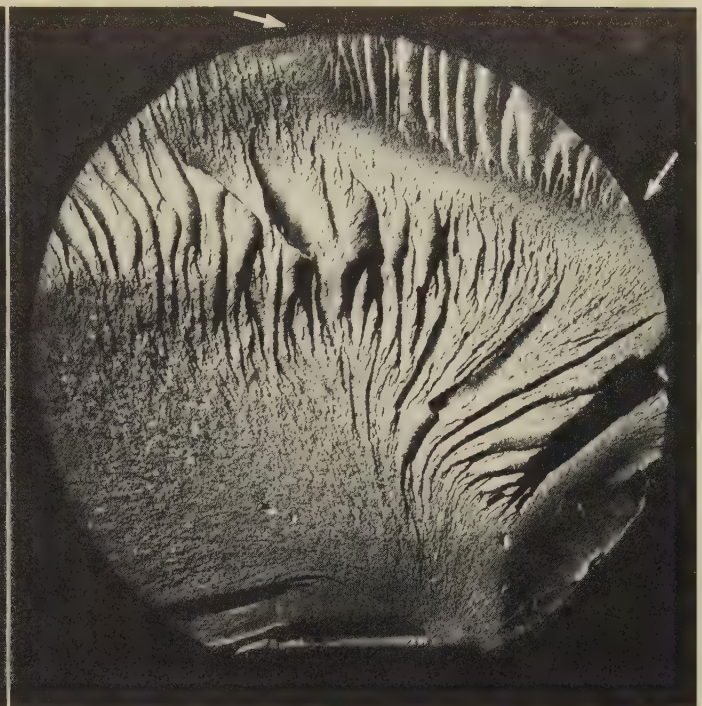
3449 An impact fracture in a 1 1/4-in.-diam notched bar of annealed class 610 (T1) tool steel broken for inspection by two hammer blows. The crack from the first blow started at the notch at bottom and halted at the arrows, penetrating the area at top right only with the second blow. See 3450, 3451.

3450 An impact fracture in a 1 1/4-in.-diam notched bar of class 610 (T1) tool steel that was broken for inspection same as the bar in 3449. The crack resulting from the first hammer blow, which started at the notch at right, shows the network of intersecting fine markings called "Wallner lines". The crack that resulted from the second hammer blow is at left.

3451 An impact fracture in a notched bar of class 651 (M3, class 1) tool steel broken for inspection same as in 3449 and 3450. The crack from the first hammer blow originated in the notch at right (origin is readily located by tracing back to beginning of fan-shaped pattern of radial marks); this crack penetrated the area at left with the second hammer blow.

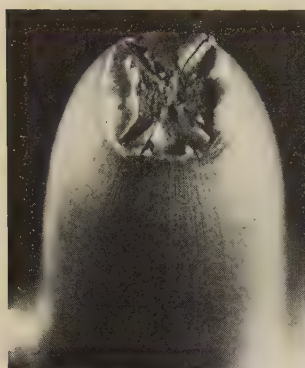
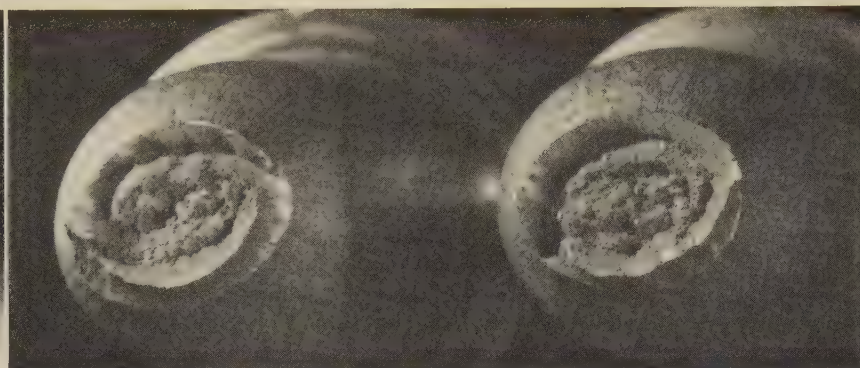
Light fractograph
3452, 3453

Tensile-test fractures in hot rolled type 410 stainless steel bar, showing contours that reflect high ductility and mechanical anisotropy, the latter of which resulted from rolling. At left (3452) is one fracture surface of a low-carbon specimen heated 6 hr at 745 C (1373 F) and air cooled before testing. At right (3453) are the mating fracture surfaces of a specimen tested in the as-hot-rolled condition. Both "square" (3452) and oval (3453) fracture surfaces are unusual in round bars.

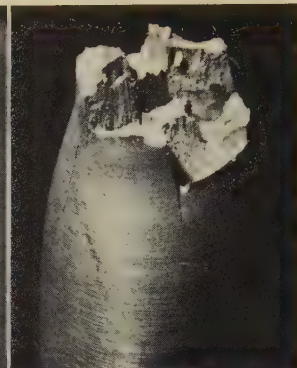
3454 Surface of tensile fracture in hot rolled type 431 stainless steel that was tempered at 663 C (1225 F).

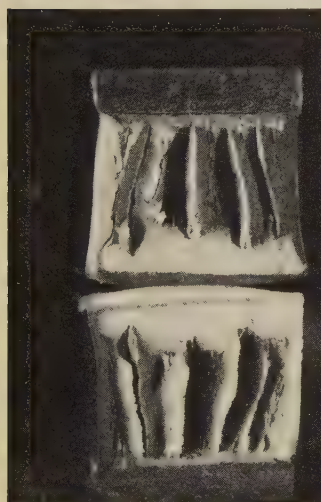
3455 Mating surfaces of an impact fracture in a specimen taken from a flat bar of type 431 stainless steel oil quenched from 954 C (1750 F) and tempered to a hardness of 248 Bhn.

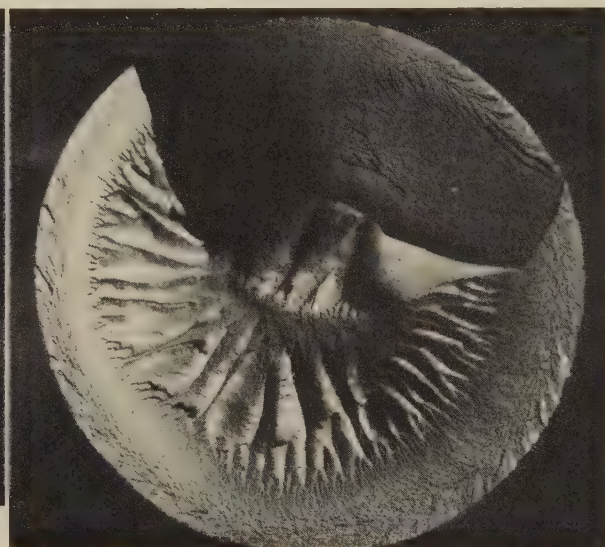
3456 Torsion fracture in type 440C stainless steel annealed at 871 C (1600 F), pickled in 15% H₂SO₄ plus an inhibitor, and cold drawn. Chevron pattern at edge indicates that the crack ran clockwise from its origin at top. Note pronounced radial marks.

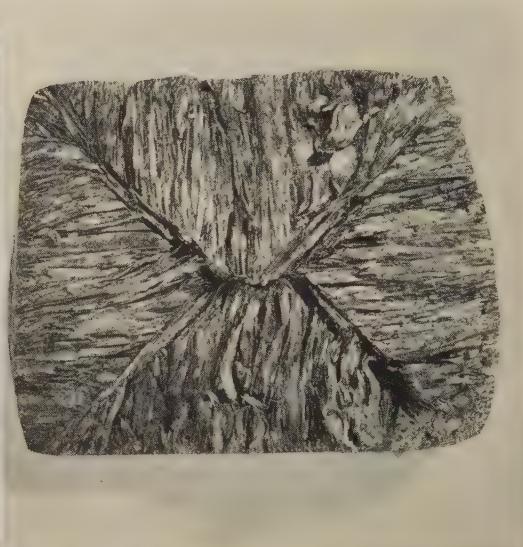
3457 Woody fracture surface of an ingot of 302B stainless steel (2-3% Si) that broke during an early blooming-mill pass because of casting-dendrite patterns. The ingot had a high silicon content and was overheated.

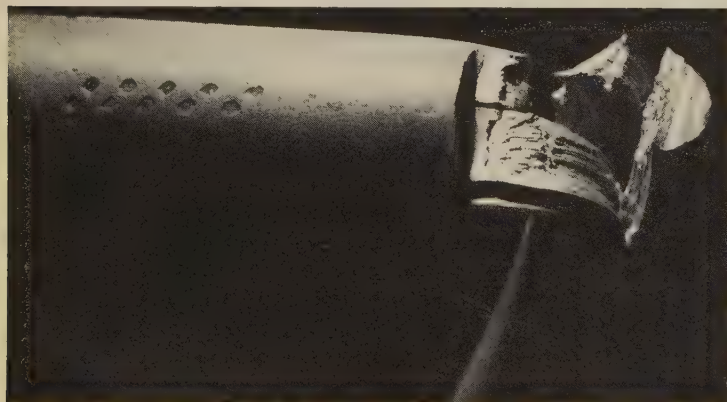
3458 Surface of a fracture produced by notching and bending a hot rolled ¾-in.-diam bar of type 303(Se) stainless steel. The woody nature of the fracture is due to centerline segregation of selenium, which altered the ductile behavior of the central zone. Such fractures are sometimes termed "fibrous".

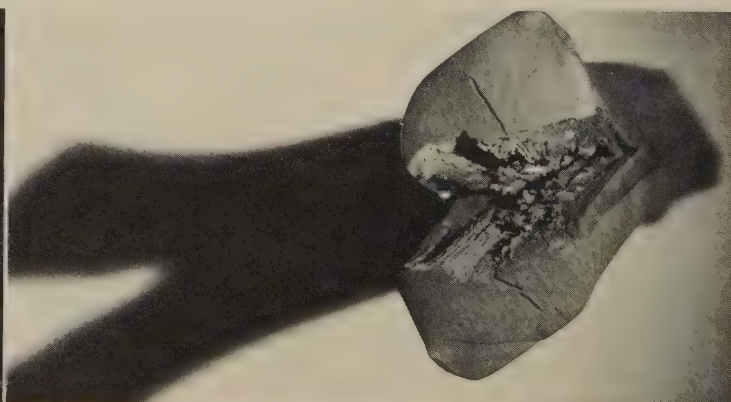
3459 End of a billet of type 309 stainless steel, showing a woody, longitudinal fracture. The outer layers of the billet deformed properly during rolling, but excessive segregation at the center resulted in the formation of a brittle region, which led to this classic "alligator" fracture.

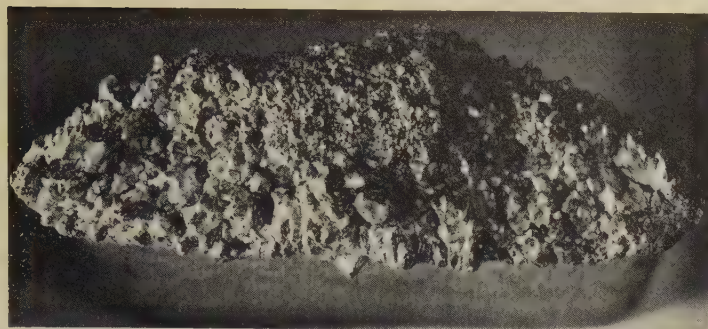
3460 Surface of a "rock candy" fracture in a bloom of type 302 stainless steel. An abnormally high silicon content, and inadvertent overheating at 1357 C (2475 F) for $\frac{3}{4}$ hr after the first blooming-mill pass, caused excessive grain growth; second pass then resulted in intergranular fracture. See 3461.

3461 Higher-magnification view of fracture surface in 3460 (above). This bloom fractured during rolling, splitting apart and wrapping itself around the roll. Note lack of deformation of grains. The fracture surface was cleaned with H_2SO_4 and was brightened with a solution containing HNO_3 and HF.

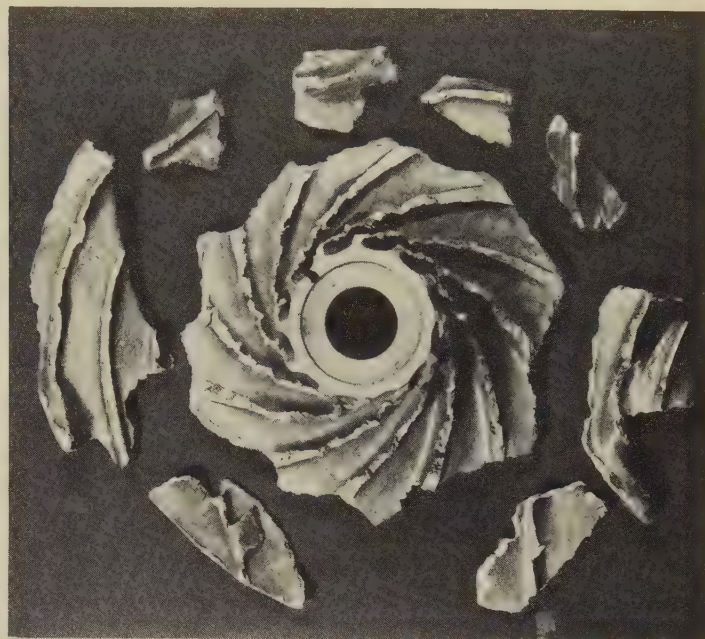
3462 Plan view of the collected fragments of a fractured turbosupercharger impeller that was cast of aluminum alloy 355 and that fractured due to internal stresses developed by gas porosity that evolved during freezing. See also 3463 to 3466.

3463 Elevation view of the hub of the impeller shown in 3462 (above), displaying the surfaces of the fractured vanes. Note the mechanical damage of the edges of the vanes; much fracture detail was destroyed by this damage after fracture.

3464 Microstructure of the cast aluminum alloy 355 impeller shown in 3462. The large void was formed by solidification shrinkage. See also 3465 and 3466 (next page).

3465, 3466 Continuation of the series begun in photograph 3462 on the preceding page, on a fractured impeller hub cast of aluminum alloy 355. Macrograph 3465 (at left) is of half a section through the hub, showing the coarse, and highly dispersed, gas porosity due to gas that had been in solution in the melt but precipitated as bubbles during freezing of the casting. Fractograph 3466 (at right) shows a fracture surface of one of the fragments of the hub shown in photograph 3463. The small reflecting spots are the shiny walls of bubbles intersected by the fracture; note that these spots are distributed quite uniformly.

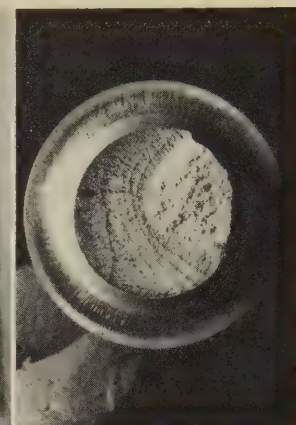
Light fractograph 4X
3467 Fatigue-fracture surface of an aluminum alloy 2024-T4 specimen that was broken after 43 million cycles of stress to 138 MPa (20 ksi). Note the crack-growth halts that resulted from machine slowdowns.

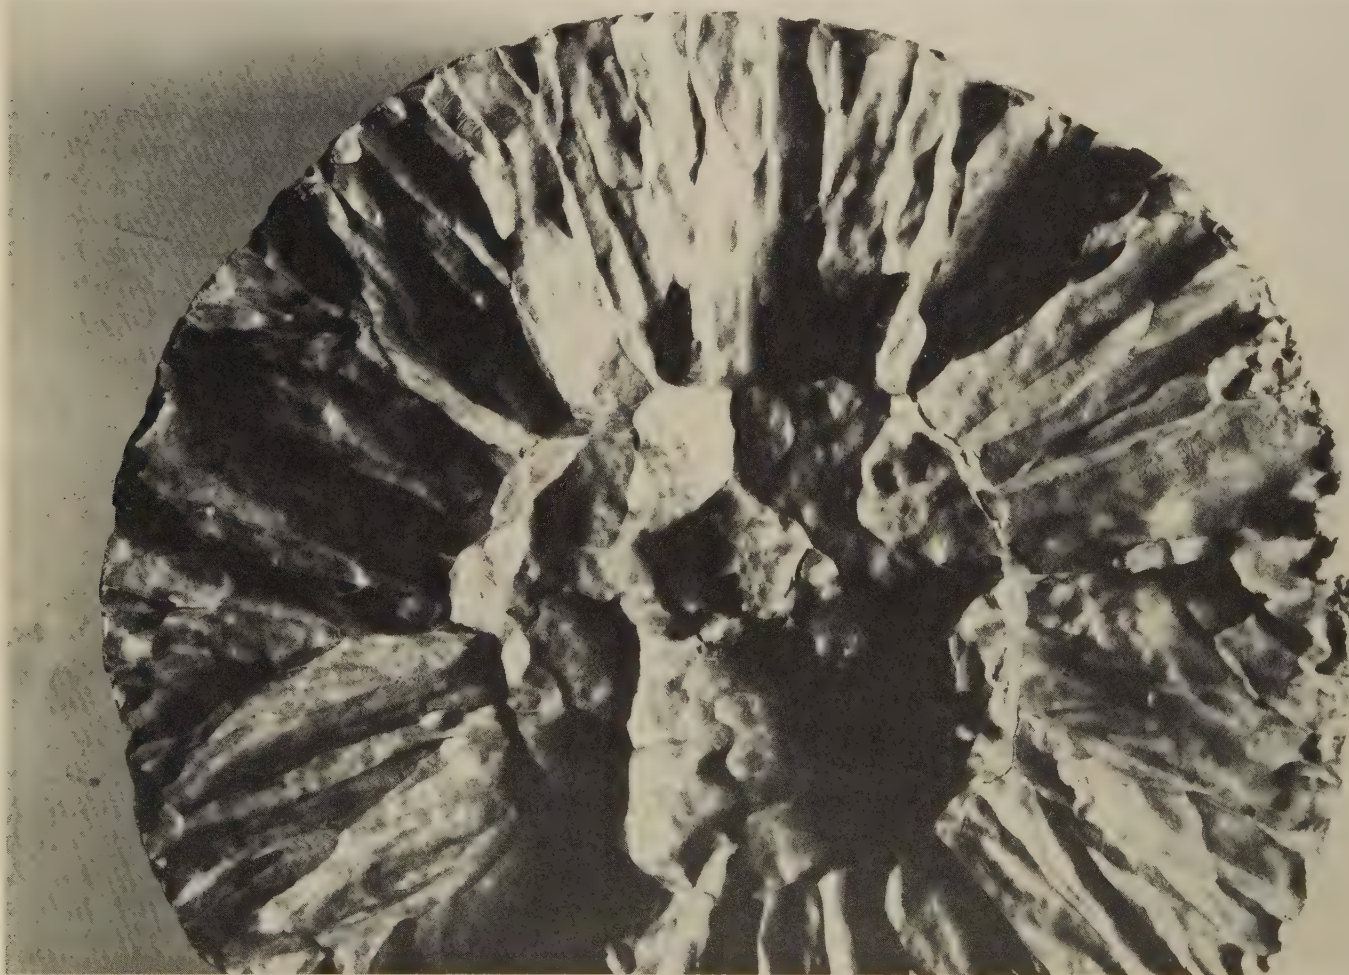
3468 Surface of a fracture in a 7 1/2-in.-diam brass ingot that broke because of casting-dendrite patterns. The combination of overheating prior to rolling, a segregation in structure in the central region, and the stresses applied by rolling reduction was sufficient to generate an interdendritic rupture. Note, however, that although the fracture mechanism is interdendritic, there is relatively little secondary cracking detectable. Note also that the interdendritic surfaces are remarkably smooth.

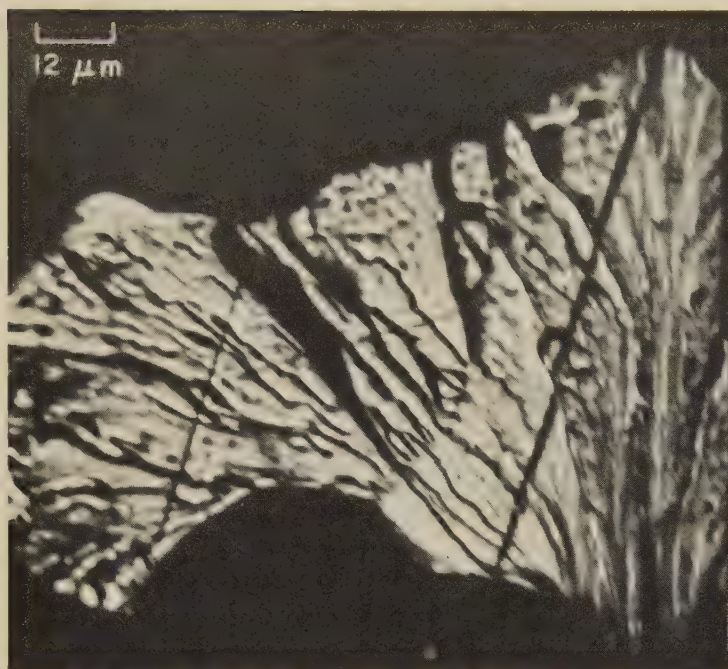
3469 Surface of an impact fracture in a notched $\frac{1}{4}$ -in.-square specimen of as-rolled Armco ingot iron (0.013% C, 0.019% Mn, 0.003% P, 0.018% S, 0.001% Si, 0.02% Ni) that was broken at -196°C (-321°F). The crack entered the area at bottom in this view, and progressed upward by quasicleavage. The two diagonal lines are mechanical twins. Fractographs 3470 to 3472 show the effect of annealing at various temperatures on the appearance of impact fractures in this same material; fractographs 3473 to 3480 (next two pages) show fractures of this material as affected by heat treatment, cold work, and hydrogen embrittlement.

3470 Impact-fracture surface of a specimen of the same material as in fractograph 3469, but which was annealed at 1000°C (1832°F) for 2 hr and furnace cooled before impact at -196°C (-321°F). Fracture was by cleavage parallel to a crystallographic plane. The discontinuity at arrow (near right edge) is believed to lie at a grain boundary. The dark "holes" presumably were the sites of inclusions. See also fractographs 3471 and 3472.

3471 Impact-fracture surface of a specimen of the same material as in 3469 and 3470, but which was annealed at 1200°C (2192°F) for $1\frac{1}{2}$ hr and furnace cooled before impact at -196°C (-321°F). Crack propagation was mainly from left to right by cleavage, which produced many local river patterns. A prominent set of intersections of $\{112\}$ twins with the plane of the fracture facet is evident at several definite angles. See also 3472.

3472 Impact-fracture surface of a specimen of the same material as in 3469, 3470 and 3471, but which was annealed at 1350°C (2462°F) for $1\frac{1}{2}$ hr and furnace cooled before impact at -196°C (-321°F). Annealing at a higher temperature than that for 3471 resulted in a very coarse grain size. This facet shows two crack origins, at upper and lower right, with the two crack fronts joining at the dark fissure denoted by the arrow at right edge (above center).

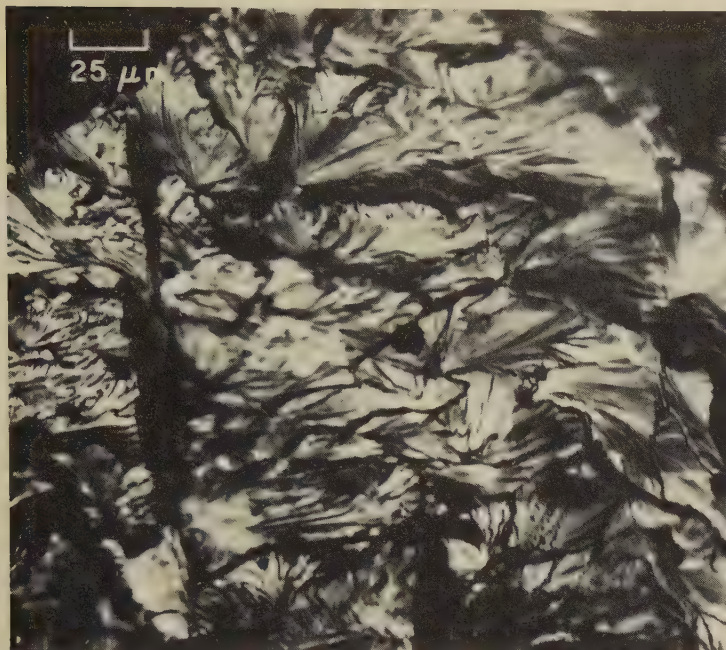
3473 Impact fracture in a specimen of the same Armco ingot iron as in fractograph 3469 (opposite page), but which was heated at 1200°C (2192°F) for $1\frac{1}{2}$ hr and water quenched before impact at -196°C (-321°F). This is a cleavage fracture, but the surface is quite distorted. See also fractograph 3474, at right.

3474 Impact fracture in a specimen of the same material and heat treatment as in 3473, but which was then heated to 700°C (1292°F), held at temperature for 1 hr, and furnace cooled, before impact at -196°C (-321°F). Primary crack origin is at top here, slightly to right of center. There are many involved river patterns. Note the blocklike steps at upper left.

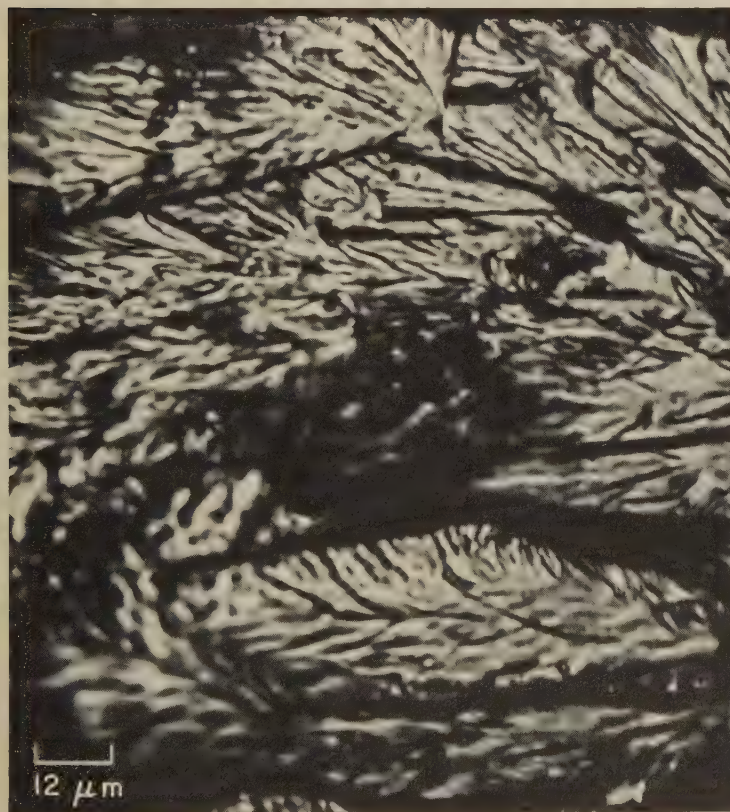
3475 Effect of cold work after heat treatment on impact fracture in same Armco iron as in 3469-3474. Prior to impact at -196°C (-321°F), specimen was heated 2 hr at 1000°C (1832°F), furnace cooled, then hammered at room temperature to 50% reduction in thickness. Coarse river patterns somewhat resemble those in 3469. The central secondary cleavage resulted from twinning.

3476 Impact fracture in a specimen of the same material, and with the same thermal and mechanical treatment, as in 3475, but which was embrittled by cathodic charging of hydrogen and was fractured by a hammer blow at room temperature. The crack entered the area that appears at lower left in this view. Cubic symmetry indicates that this is a (001) facet.
